CROSS

Confidential Reporting on Structural Safety

Newsletter No. 53 | January 2019

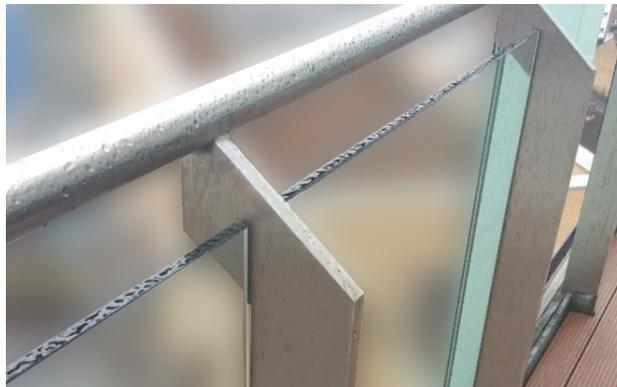
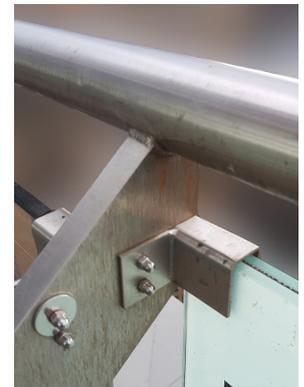
● **Figure 1**
Left: Glass panel with no top restraint | Right: Restraint fitted

A reporter expressed the following concerns about the structural stability of cantilever glass infill panels between a steel post and hand rail balustrade system at a high-level apartment block:

1. The glass infill panels are set in to a mastic filled channel at the base which in places is deteriorating;
2. Some infill panels are laminated, and some are non-laminated;
3. The steel post and handrail balustrade system is not connected to the glass infill panels.

According to the reporter, in the event of a failure at the base, there is no secondary fixity to prevent complete failure of the glass sheet. The height of the apartment means that patio furniture can get blown right round three sides of the block of flats by wind. In the event of impact from the furniture, the non-laminated glass could shatter.

Here, the glass simply cantilevers from a mastic filled channel at the base which is not a robust detail, and does not provide safety either for residents or passers-by.

if the glass breaks from impact then; firstly, there would be a large gap below the balustrade rail through which someone could fall and, secondly glass shards or granules could fall on the ground below. Another possibility would be that a panel was dislodged outwards, without breaking, but with the same consequences.

The reporter feels that all the non-laminated sheets of glass need to be replaced with laminated and a secondary top fixing bar in stainless steel added to exploit the existing post and rail system to hold the top of all the glass sheets given what appears to be the deterioration of the single base fixing.

Remedial work was undertaken to fix the top edges of the glass sheets to the hand rail on flats with the same detail.

Small changes to the design would have resulted in a much safer scenario and substantially reduced the risk. The usual procedure for a designer would be to consult the **CWCT >** standards and guidelines for glazing, and the **CIRIA Guide to Glazing at Height C632 >**.

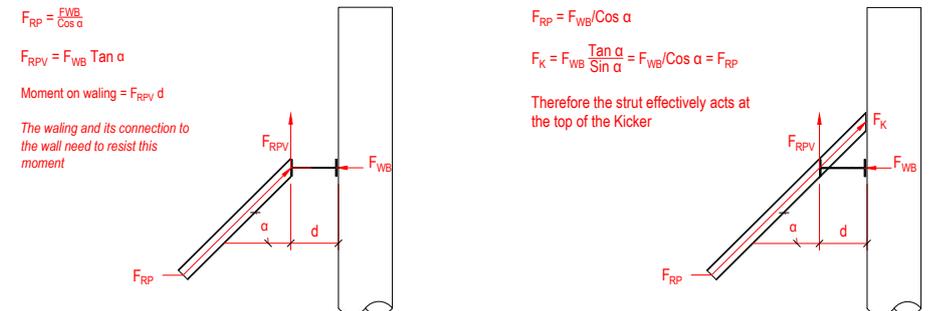
Figure 2
Raking prop to outer flange of waler beam; Left: Without kicker | Right: With kicker

The only useful guidance the reporter found is **CIRIA C517, Temporary propping of deep excavations - guidance on design (1999)**, where Figure 10.5 shows 'Typical end detail for a raking prop (after Goldberg et al, 1976)'. The raking prop is shown as meeting the centreline of the waler at the outer flange (the inner flange being fixed to a vertical soldier beam, which is assumed could equally be a sheet-piled wall or a contiguous piled wall).

An inclined 'kicker' or 'spur brace' is provided, presumably to resist the upwards component of the prop force which has to be resisted where the prop joins the outer flange. The idea is presumably that the horizontal force component from the prop force passes into the waler web and then along the waler to resist the horizontal forces from the soil.

Unfortunately, when the forces at the top of the prop are resolved, if the kicker is to resist the vertical force, its axial force must be similar to the prop force, unless it is extremely

steep; in fact, it is usually approximately in line with the prop.

This means (resolving forces) that the prop force passes up through the kicker to where the kicker meets the wall - and the waler doesn't spread the horizontal prop force along the wall.

If forces from adjoining members do not meet at a point, then a moment will be induced and in this case the forces must be resolved to eliminate torsion on the waling.

If the junction between prop and waler beam is an assumed pin, then the system can be a structure with the eccentric vertical component of the prop creating bending in the piling (just below the waler fixing point).

Alternatively, if the prop to waler junction is assumed to be fixed, the bending will be shared between the waler and the piling. This could only work if the piling/raker have adequate bending capacity.

The reporter is correct in that, while the inclusion of a kicker provides a load path for the vertical force component of the raking prop, the horizontal force component of the raking prop will also pass through the kicker if it is aligned with the raking prop. In this case, the waler beam will not spread the prop force along the wall.

The reporter has shown this to several temporary works designers. Some of them already know about the problem but some just can't see what the problem is. Solutions identified so far (and used) are to either have a near-vertical kicker (or tie-down underneath), then checking that this force can be resisted vertically, or to join the prop at the inner flange, not at the outer flange, which requires some overhead welding on site.

This issue can be resolved through good detailing, which could include aligning the raking prop with the inner flange of the waler. However, tolerances should always be allowed for, particularly for sheet pile walls where there can be packing between the sheet pile wall and the waler beam, so there can still be a moment. To overcome any torsional effects, stiffeners can be effective.
